# **LOSS PREVENTION REVIEW TEAM**

**DOLLIVER BUILDING INCIDENT OF SEPTEMBER 21, 2003**

**Report to the Director of the Office of Financial Management**

April 2004

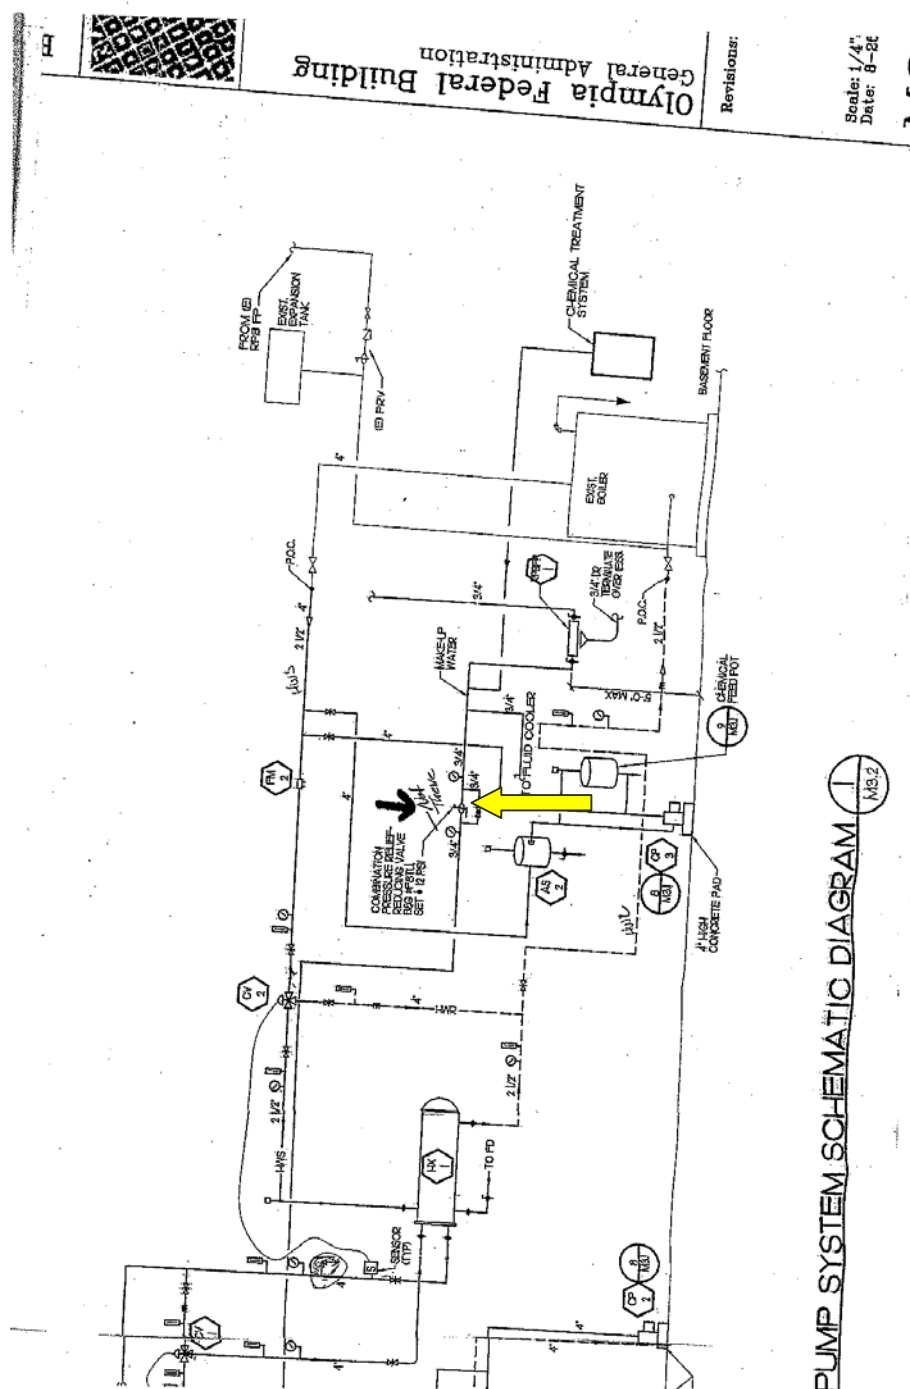
## APPENDIX A – PUMP SYSTEM DIAGRAM (ARROW SHOWS MISSING VALVE)

- BiWell Construction failed to install a pressure relief valve stipulated in the plans for the HVAC system. It is likely that this would have prevented or mitigated the loss. (See Appendix A Pump System Diagram).
- The mechanical design engineer should have checked the system prior to start up which could have detected the missing valve.
- The system was designed to include a surge tank, which would compensate for pressure surges. The after incident investigation by GT Engineering revealed that the surge tank was defective and non functional at the time of loss.

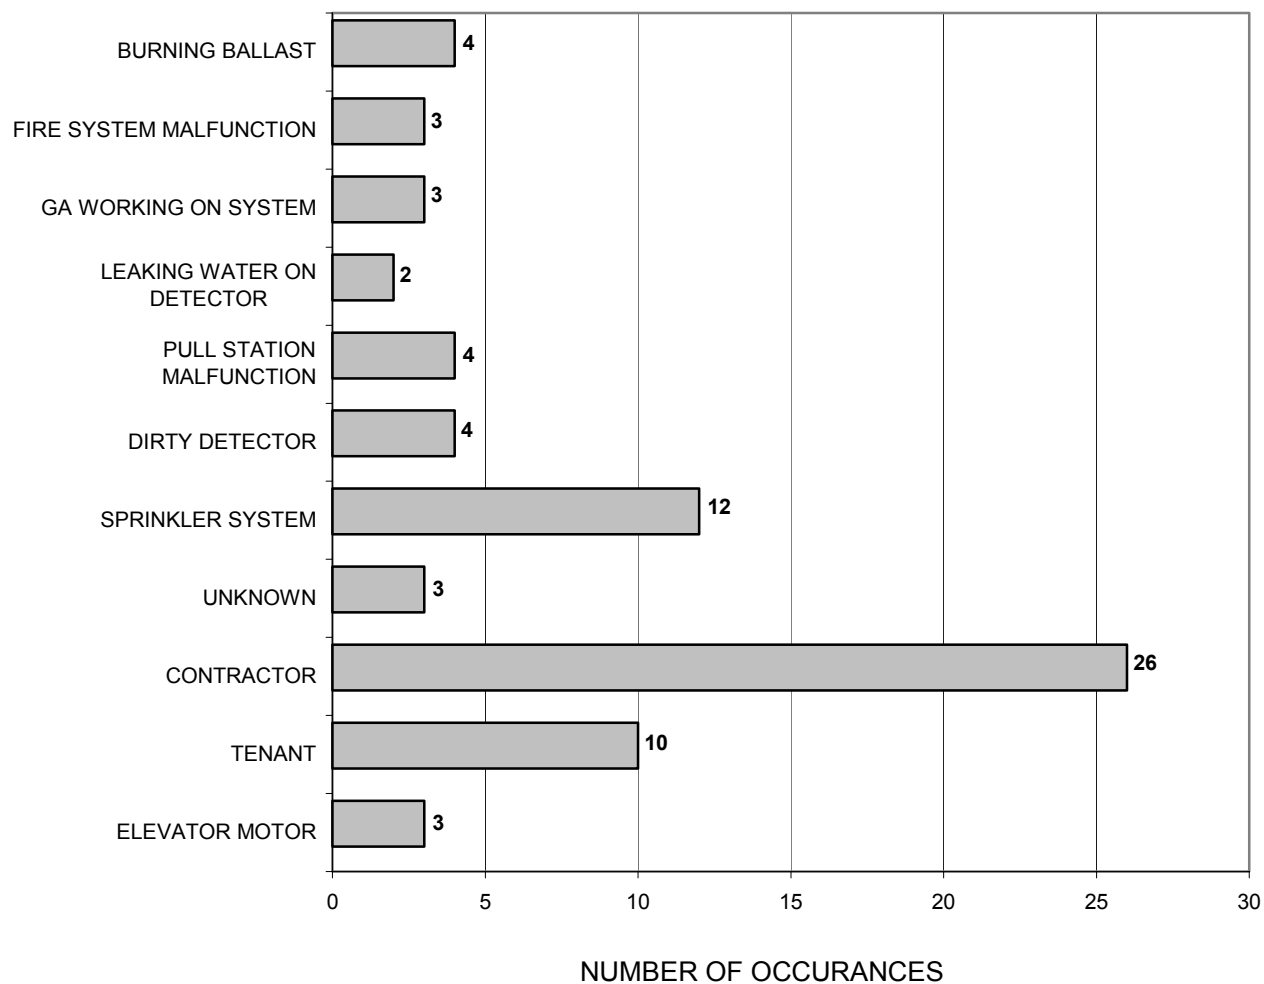
**APPENDIX C – GA ALARM CAUSE CHART****ALARM CAUSE/FREQUENCY JAN. '02 THROUGH JAN. '04**

It appears that at some point GA made a policy decision not to respond to all trouble alarms after hours due to limited staff and the effort to control overtime costs. There are numerous fire panels and HVAC systems on the Capital Campus. Alarms can be generated due to dirt; moisture or shorting for other reasons and in some cases the cause of the trouble alarm cannot be diagnosed. The fall and winter seasons usually generate more alarms due to moisture. GA records show that most alarms occur in and around construction areas due to contaminants getting into the fire alarms (See Appendix C Alarm Chart).

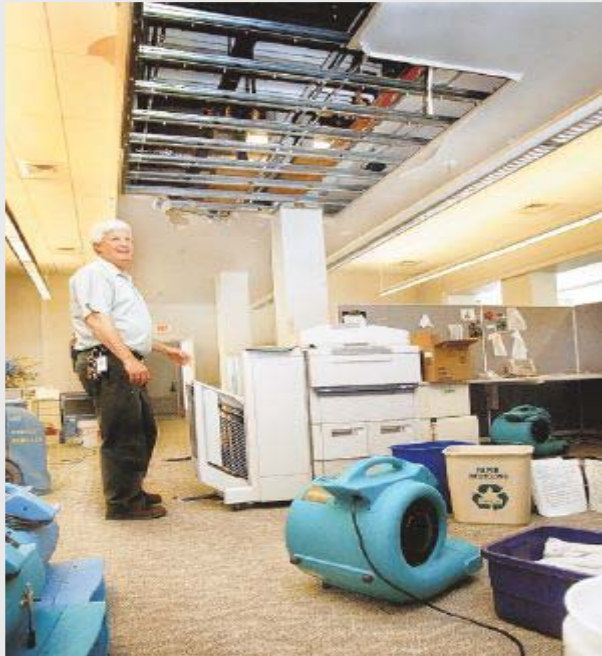
With the din of multiple air blowers in the background, Steve Jones, manager of the James M. Dolliver Building, glances back Monday at some of the damage resulting from a broken water pipe that soaked carpeting and damaged office equipment at the building on Capitol Way. The water also brought down a section of ceiling.

Officials think a pipe that supplied water to cool an HVAC system burst around 10 p.m. Sunday and leaked all night into an area between the first and second floor. At some point much of the first-floor ceiling caved in, swamping the first floor and allowing water to rush into the basement as well.

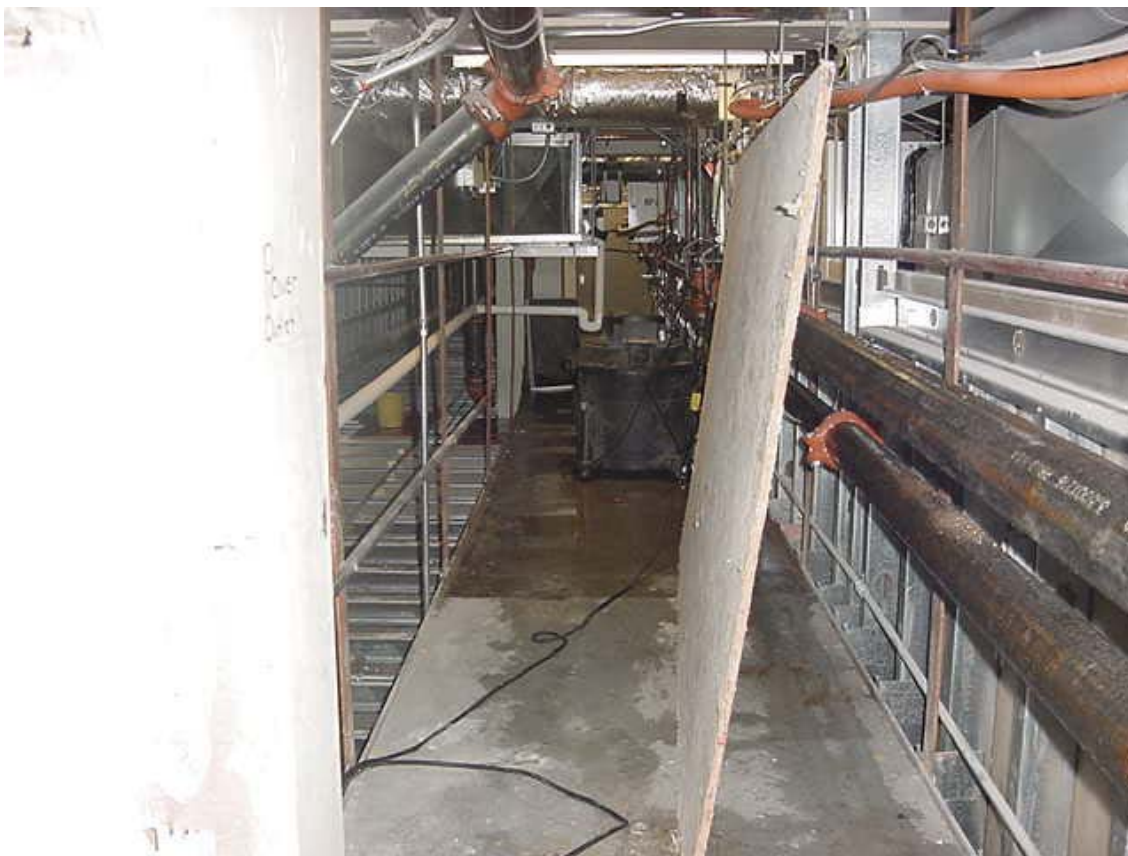
**#1 – Catwalk**

**Photo # 1 - Catwalk above first floor of the Dolliver Building. HVAC metal braided flex hose burst at this level.**

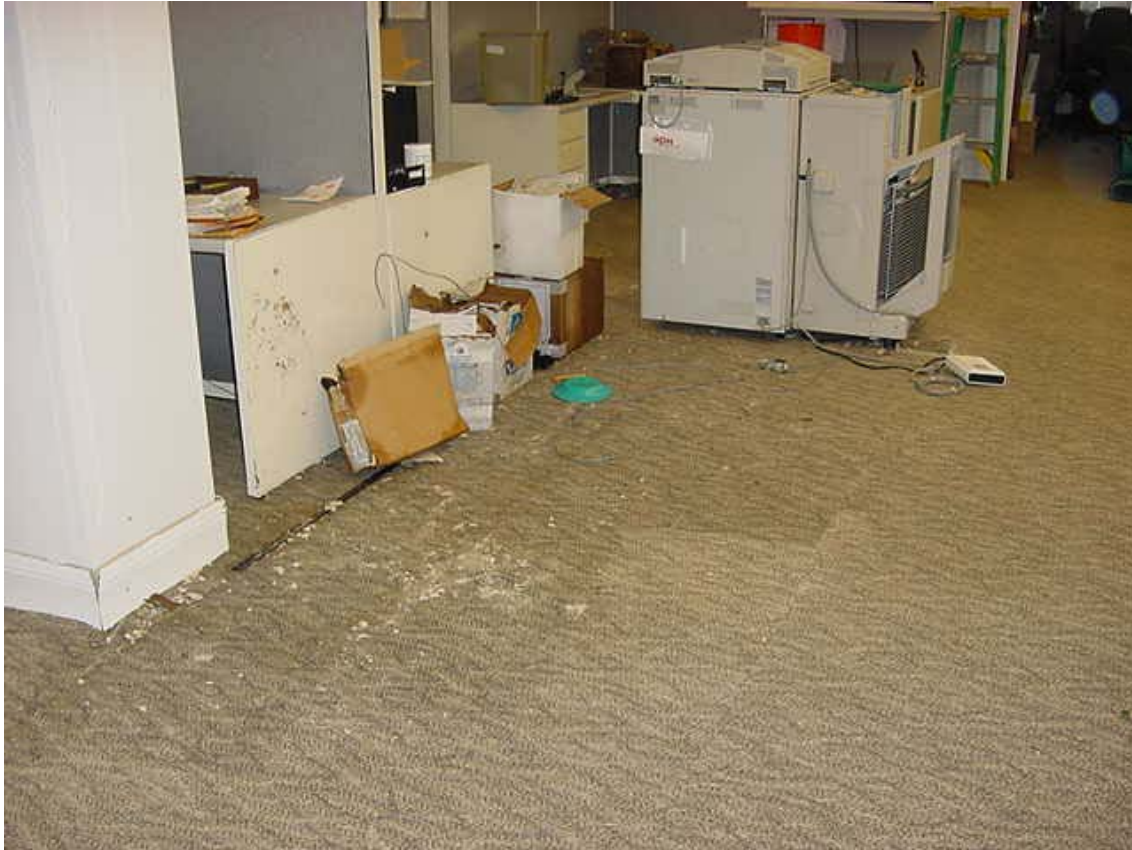
**#2 - Wet Carpet**

**Photo # 2 - Wet carpet on floor one of the Dolliver Building. Carpet was glue-down type and all wet carpet had to be replaced.**

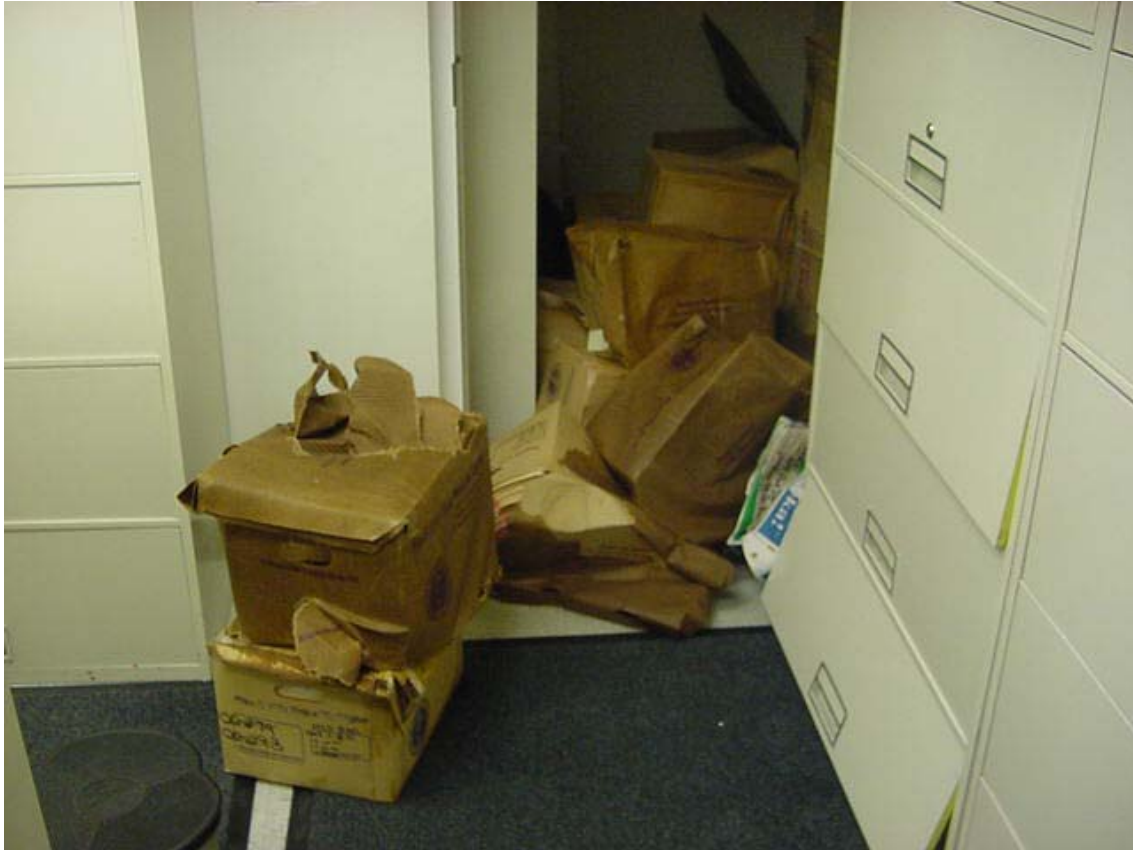
**#3 - File Room – Wet Boxes**

**Photo # 3 - Wet boxes in file room on first floor. Records that were stored in cardboard boxes were damaged.**

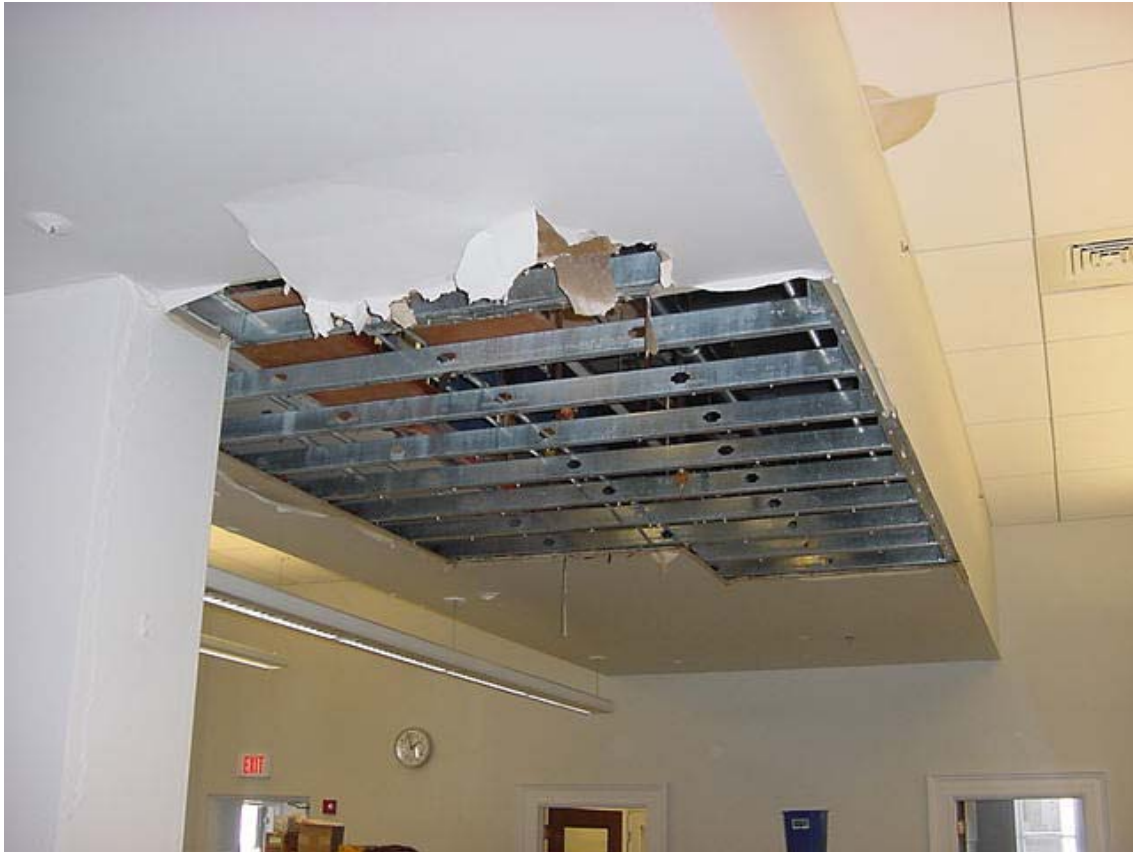
**#4 – Ceiling Damage**

**Photo # 4 - Ceiling damage first floor.**

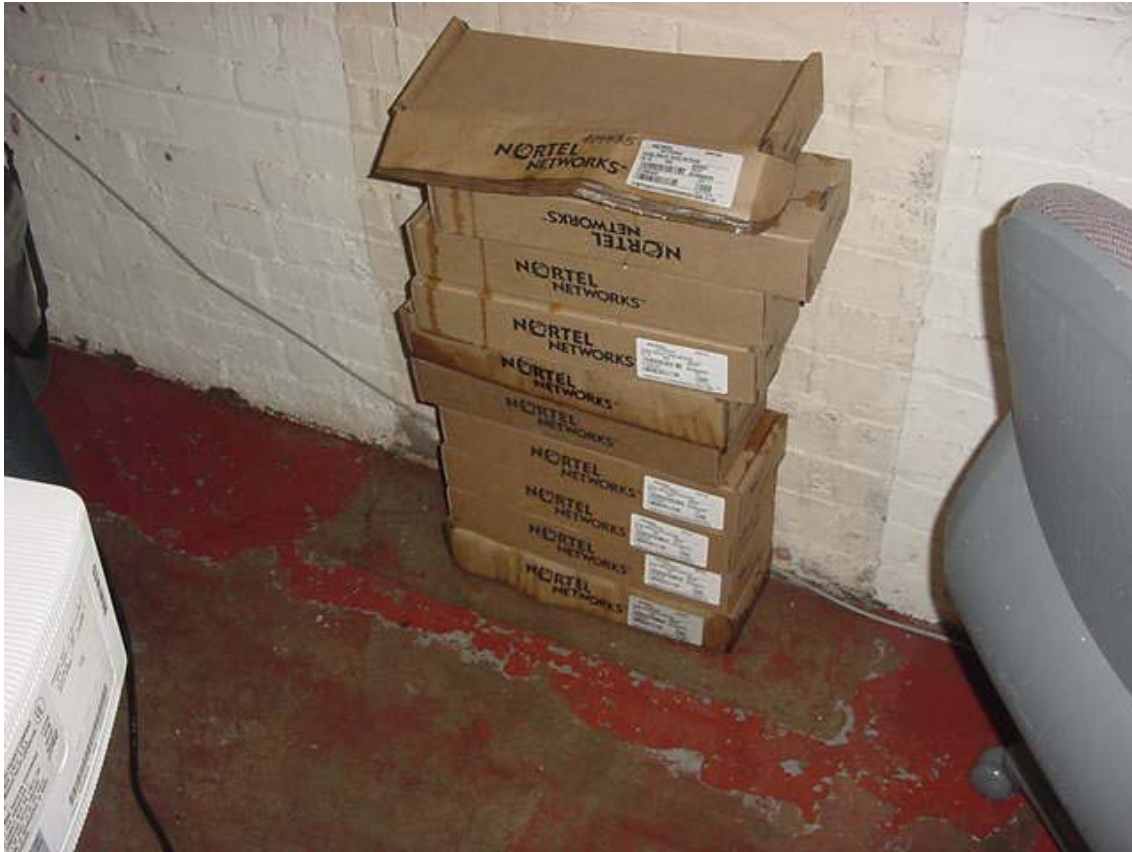
**#5 – Wet Boxes**

**Photo # 5 - Wet boxes in basement.**

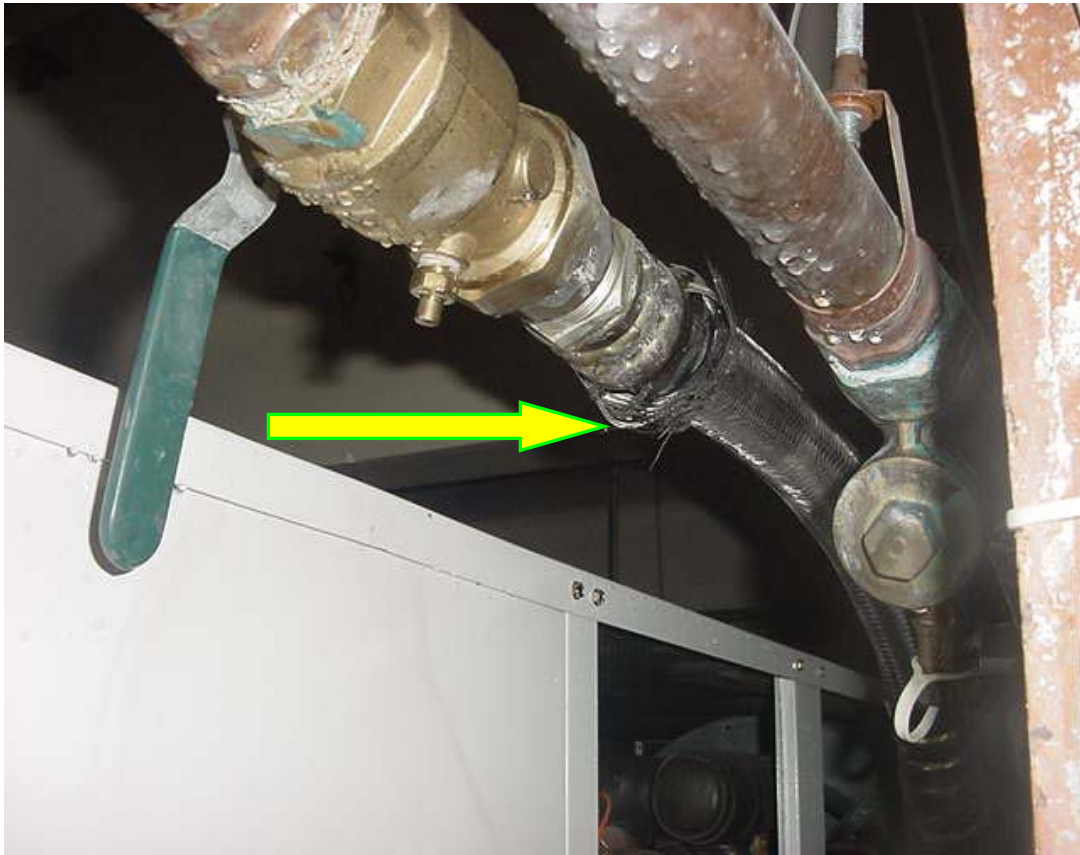
**#6 - Broken Flex Hose**

GT engineering examined several heat pump installations in the ceiling above the first floor, including the #2 unit which had experienced a rupture in a metal braided hose on September 21, 2003. We also inspected the boiler room where a test of the expansion tank was conducted at our request. The hydronic loop control system was discussed with the designer, and we requested and witnessed information that the data acquisition associated with the control system recorded.

**Photo # 6 - Metal braided flex hose burst away from crimp fitting.**

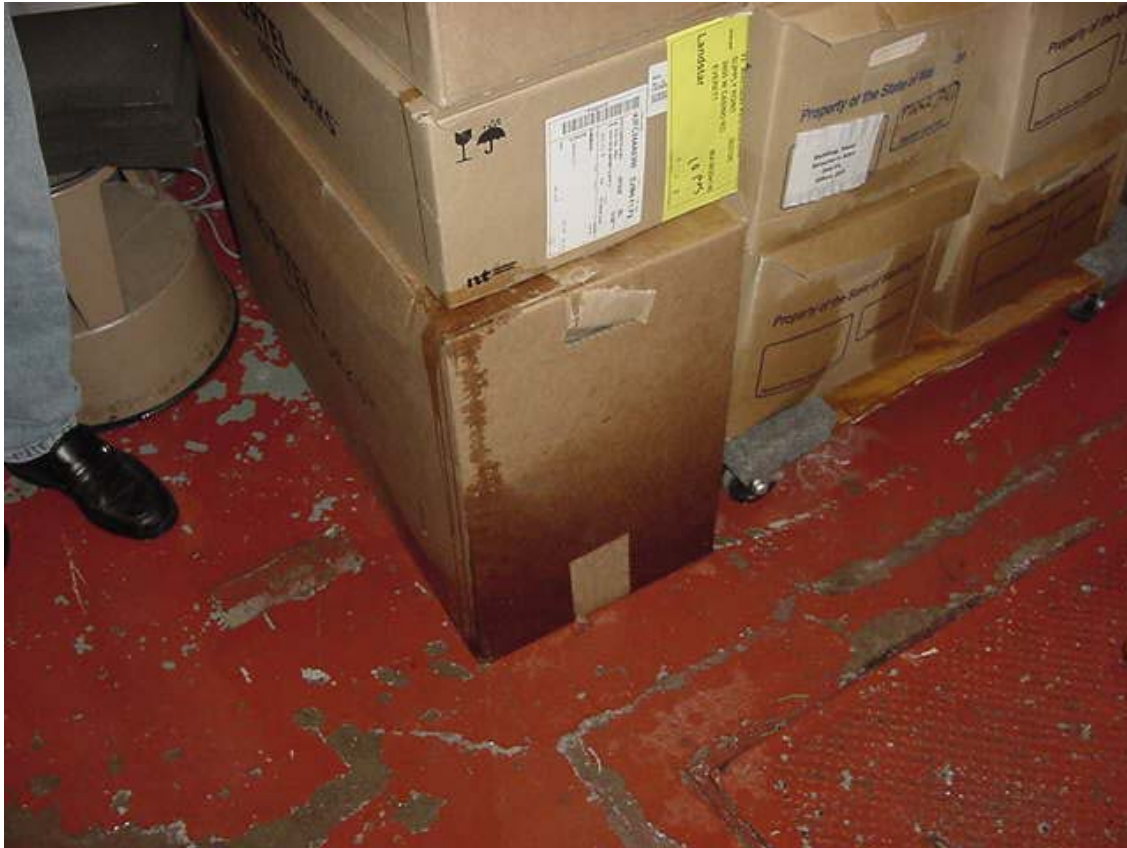
**#7 – Wet File Boxes**

**Photo # 7 - Wet file boxes in basement.**
